Investigation of the Comparative Corrosion of Aluminum and Steel Corrugated Metal Pipes in Similar Environments

September 1962

State of California
Department of Public Works
Division of Highways
Materials and Research Department

Submitted for your information is the first progress
report on an:

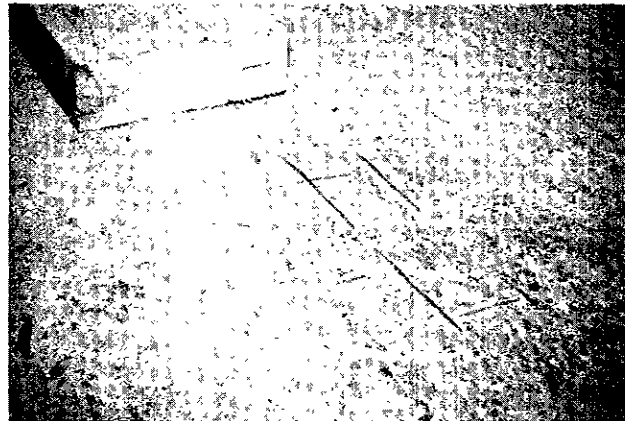
Note roughness
of concrete floor
at end of waler.

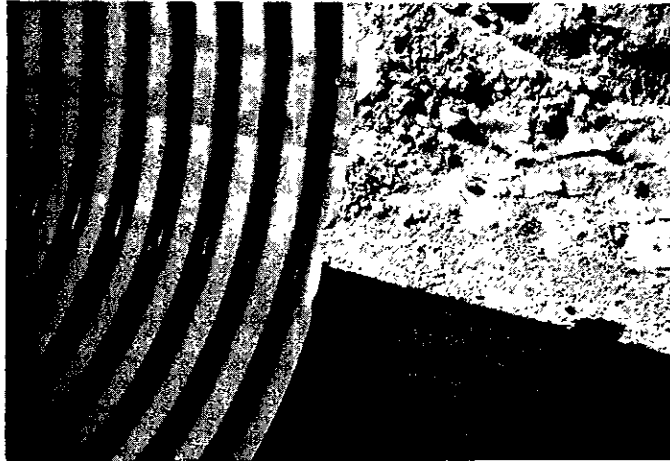
Note damaged end of
aluminum CMP due to
handling.

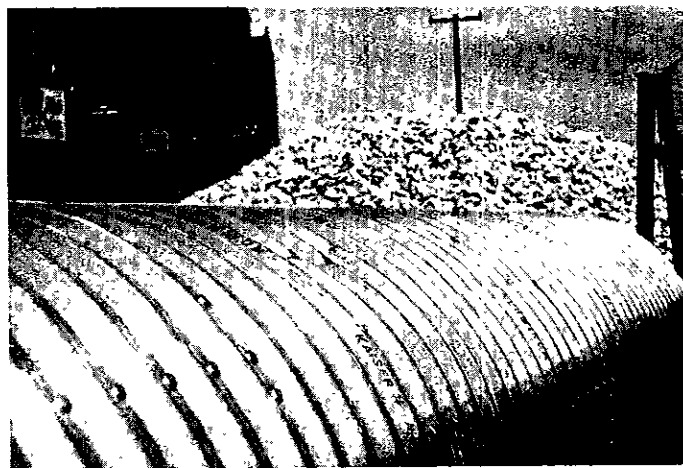
Note damaged areas
on aluminum CMP
due to handling.

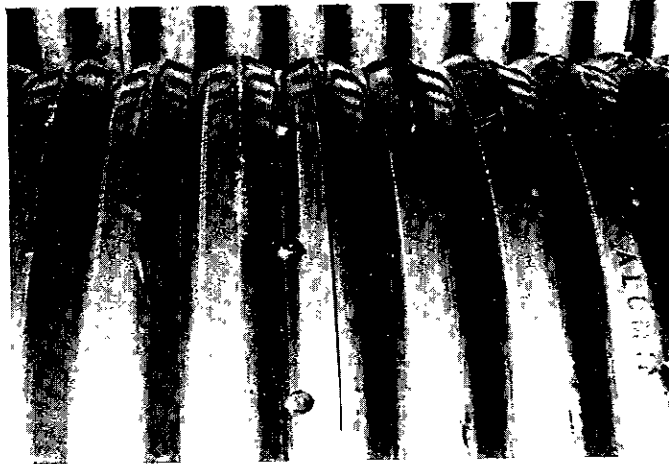
Note damaged
surface of alum.
CMP due to
handling

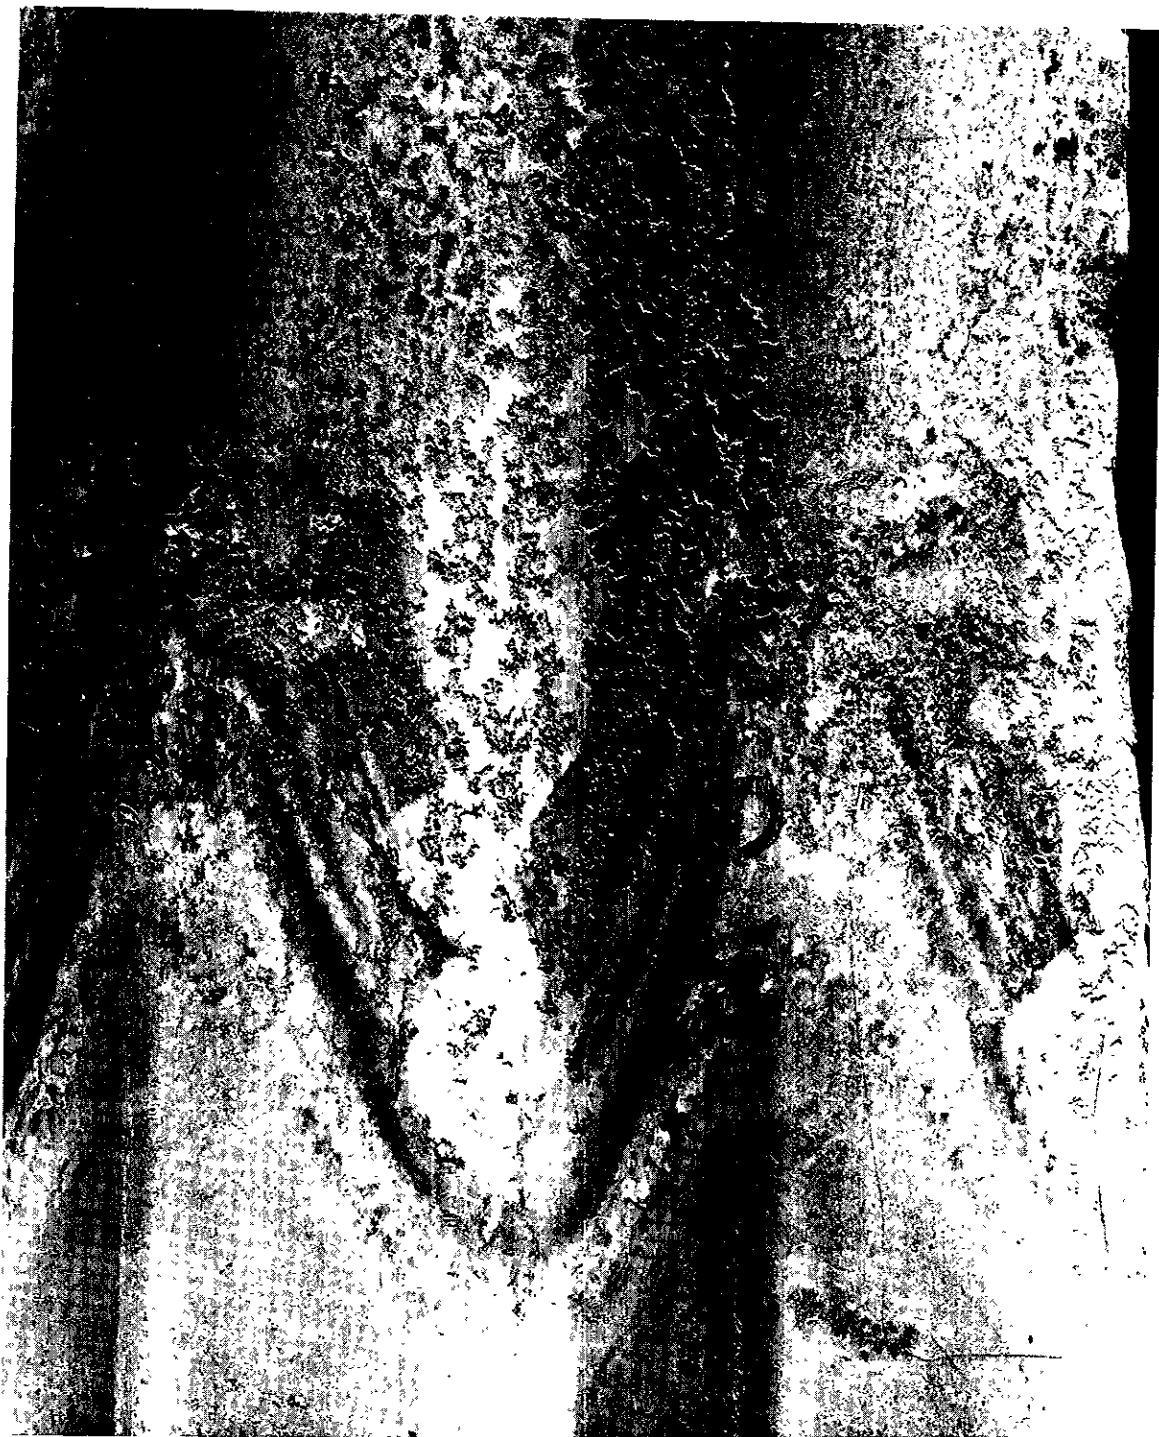
At the acid ground water test site in II-Sha-3-B, a section of aluminum CMP approximately 5" x 10" was cut from the invert after 56 days of exposure. A photo of this section of aluminum is shown on Exhibit 12 and represents the result of corrosion after 56 days of exposure.

This sample was taken from the invert of alum. CMP
after 56 days of acid exposure. Invert perforated
at 157 days of exposure.

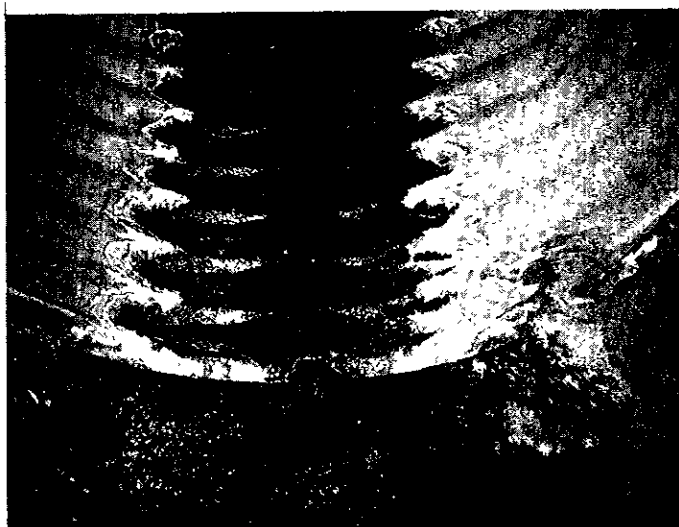
Galvanized steel CMP after 266 days of acid exposure. Invert perforated.

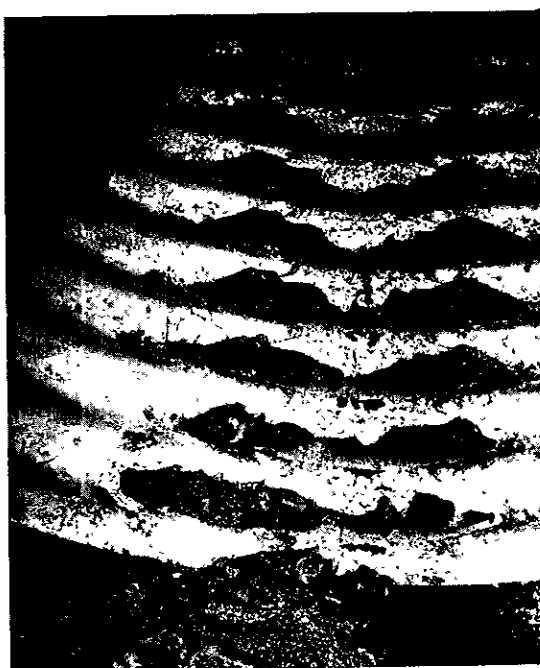
Aluminum CMP after 266 days of acid exposure. Invert perforated.

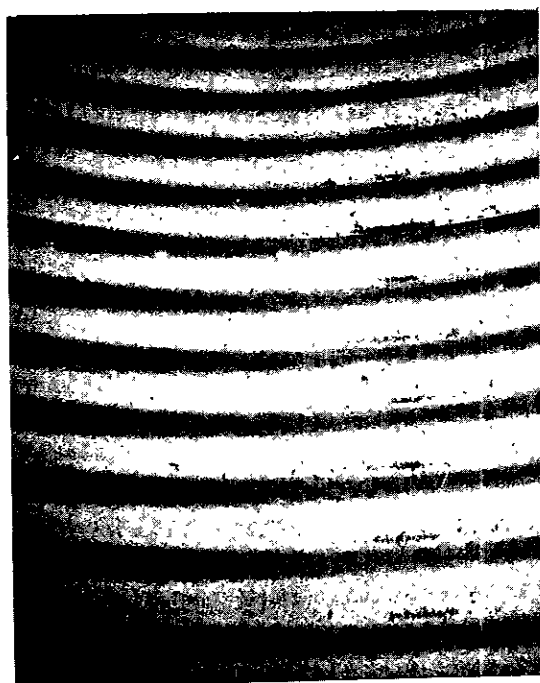
Dents about $\frac{1}{4}$ " deep in about 10 locations. Nicks about $1/32$ " deep in approx. 25 locations. Aluminum rivets have lost approx. $\frac{1}{2}$ of their original metal thickness. Some rivets have severely deformed to the point that the line of demarcation between rivet and culvert metal are hardly visible. There is evidence of plastic flow of the aluminum culvert metal due to abrasion.

Note abrasion of aluminum rivets and
denting of the surface of the pipe.

The aluminum culvert in the abrasion test site requires repair due to the excessive metal loss of the rivets. The aluminum section should be repaired with bolts to prevent the loss of the plate. At the abrasion test site the apparent order of abrasion resistance is as follows, with number 1 being the best:

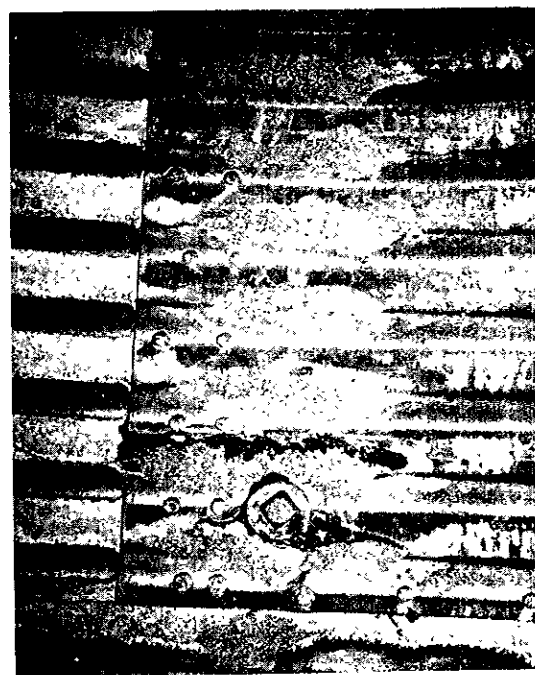
No dents or noticeable nicks on steel surface. Zinc has been abraded from the steel in some areas. Rounding of upstream surface of rivets, but no structural problems. There is abrasion of steel, but quantity of steel loss cannot be estimated.

Invert of galvanized steel CMP.
Note: Anchor bolt and rivets.

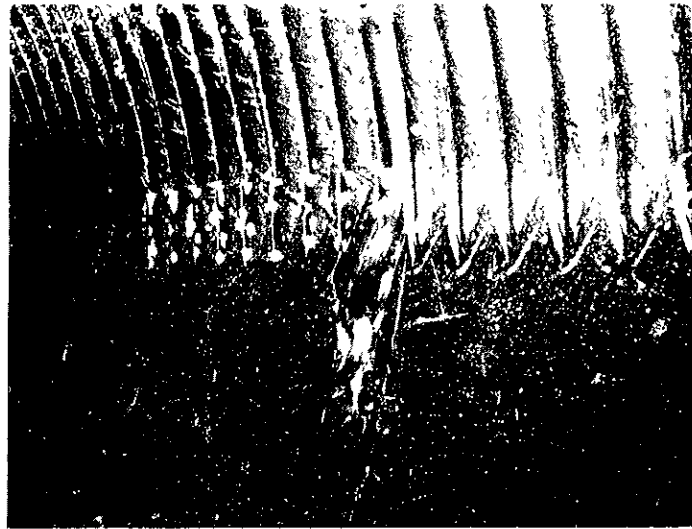
Chipping of asphalt in dipped section of pipe. Paved invert abraded in several locations, but still satisfactory as a protective coating.

187 days of
abrasive exposure

Bottom and side of asphalt dipped paved
invert pipe. Note chipping of asphalt
above paved invert. Paving is intact.
